Seattle Department of Transportation

The Americans with Disabilities Act (ADA) Transition Plan for the Seattle Public Right-of-Way

Appendix 5.6a: 2019 King Street Station ADA Assessment Report

2019 King Street Station ADA Assessment Report

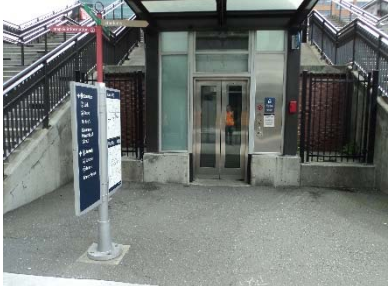
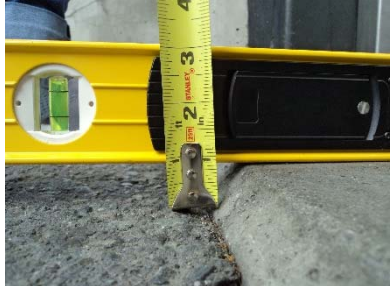
#	Location	Observed Condition	ADA Requirement
2.1.1	South lower level sidewalk (LL1) at Weller Street Bridge elevator.	Vertical level change on accessible route is greater than ¼" vertical or ½" with a 1:2 bevel. Vertical level change is 1" with beveled edge.	303.2 Vertical. Changes in level of ¼ inch (6.4 mm) high maximum shall be permitted to be vertical. 303.3 Beveled. Changes in level between ¼ inch (6.4 mm) high minimum and ½ inch (13 mm) high maximum shall be beveled with a slope not steeper than 1:2.
	Photograph(s):

Recommended Action:	Apply asphalt or pavement to match elevation of elevator door threshold.	
	Additional Comments:	This may not be considered King Street Station property/responsibility.

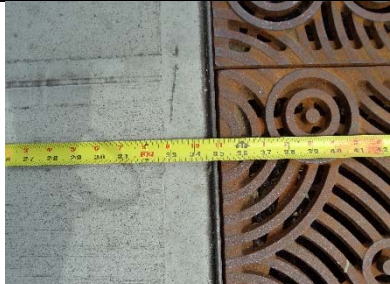
#	Location	Observed Condition	ADA Requirement
2.1.2	South lower level sidewalk (LL1) west of the tree pit at truck loading area.	The width of the accessible route is less than 36"/48". The route width is 35" wide to the outer edge of the tree pit and 53" to the inner tree pit opening.	403.5.1 Clear Width. Except as provided in 403.5.2 and 403.5.3, the clear width of walking surfaces shall be 36 inches (915 mm) minimum. R302.3 Continuous Width. Except as provided in R302.3.1, the continuous clear width of pedestrian access routes shall be 1.2 m (4.0 ft) minimum, exclusive of the width of the curb.
	Photograph(s):

<i>Recommended Action:</i>	No action required. The openings on the tree grate are $\leq \frac{1}{2}$ " and are therefore accessible and may be included as part of the minimum accessible route width.
<i>Additional Comments:</i>	This may not be considered King Street Station property/responsibility.

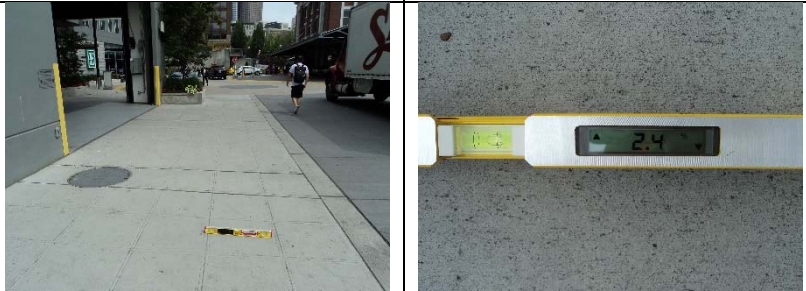
#	Location	Observed Condition	ADA Requirement
2.1.3	South lower level sidewalk (LL1) west of truck loading area.	The cross slope of the accessible route is greater than 2%. The cross slope is up to 2.4% in an isolated area.	403.3 Slope. The running slope of walking surfaces shall not be steeper than 1:20. The cross slope of walking surfaces shall not be steeper than 1:48.
	<i>Photograph(s):</i>

<i>Recommended Action:</i>	Remove and replace sections of sidewalk to reduce the cross slope to 2% maximum along the accessible route.	
	<i>Additional Comments:</i>	This may not be considered King Street Station property/responsibility.

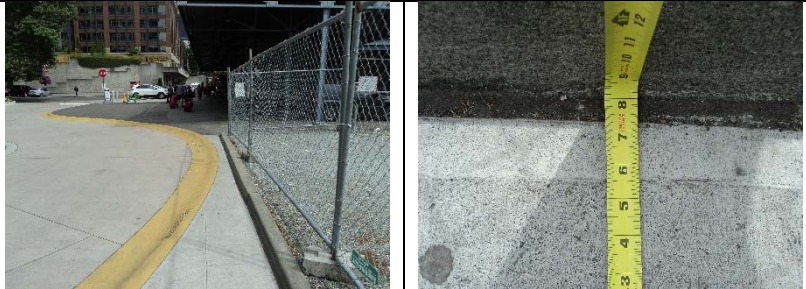
#	Location	Observed Condition	ADA Requirement
2.1.4	South lower level sidewalk (LL1) east of the vehicle turn-around.	The width of the accessible route is less than 36"/48". The route width is 7" wide (to the curb).	403.5.1 Clear Width. Except as provided in 403.5.2 and 403.5.3, the clear width of walking surfaces shall be 36 inches (915 mm) minimum. R302.3 Continuous Width. Except as provided in R302.3.1, the continuous clear width of pedestrian access routes shall be 1.2 m (4.0 ft) minimum, exclusive of the width of the curb.
	<i>Photograph(s):</i>

<i>Recommended Action:</i>	No action required. An alternative accessible route is provided on the west side of the vehicle turn-around. However, it may be worth widening this route, as it appears most pedestrians walking between the Weller St Bridge and King Street Station are using this more direct route.	
	<i>Additional Comments:</i>	This may not be considered King Street Station property/responsibility.

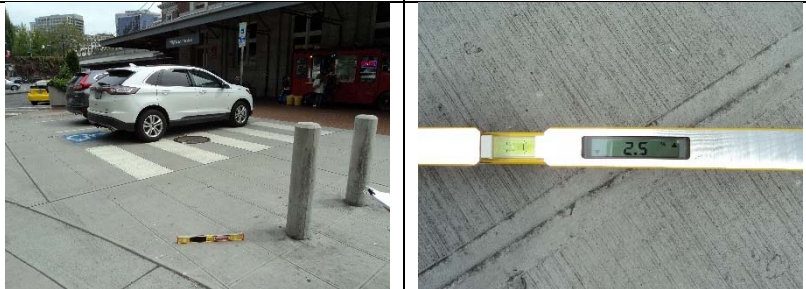
#	Location	Observed Condition	ADA Requirement
2.1.5	South lower level sidewalk (LL1) adjacent to the accessible parking space.	The cross slope of the accessible route is greater than 2%. The cross slope is up to 2.5% in an isolated area.	403.3 Slope. The running slope of walking surfaces shall not be steeper than 1:20. The cross slope of walking surfaces shall not be steeper than 1:48.
	<i>Photograph(s):</i>

<i>Recommended Action:</i>	Remove and replace sections of sidewalk to reduce the cross slope to 2% maximum along the accessible route.	
	<i>Additional Comments:</i>	N/A

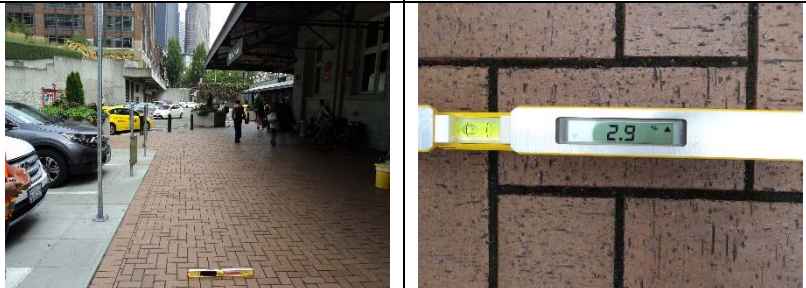
#	Location	Observed Condition	ADA Requirement
2.1.6	West lower level sidewalk (LL2) adjacent to parking.	The cross slope of the accessible route is greater than 2%. The cross slope ranges from 2.2% up to 2.9% in this general area.	403.3 Slope. The running slope of walking surfaces shall not be steeper than 1:20. The cross slope of walking surfaces shall not be steeper than 1:48.
	<i>Photograph(s):</i>

<i>Recommended Action:</i>	Remove and replace sections of sidewalk/pavement to reduce the cross slope to 2% maximum along the accessible route.	
	<i>Additional Comments:</i>	N/A

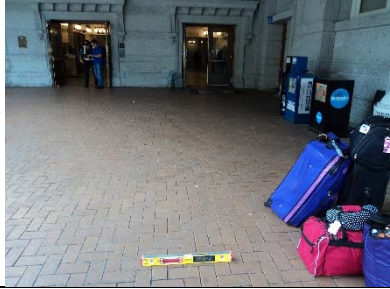
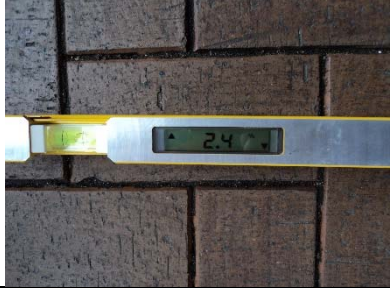
#	Location	Observed Condition	ADA Requirement
2.1.8	West lower level sidewalk (LL2) adjacent to passenger loading zone and accessible entrance.	The cross slope of the accessible route is greater than 2%. The cross slope is up to 2.4% in an isolated area.	403.3 Slope. The running slope of walking surfaces shall not be steeper than 1:20. The cross slope of walking surfaces shall not be steeper than 1:48.
	<i>Photograph(s):</i>

<i>Recommended Action:</i>	Remove and replace sections of sidewalk/pavement to reduce the cross slope to 2% maximum along the accessible route.	
	<i>Additional Comments:</i>	N/A

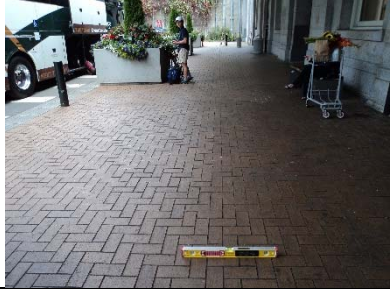
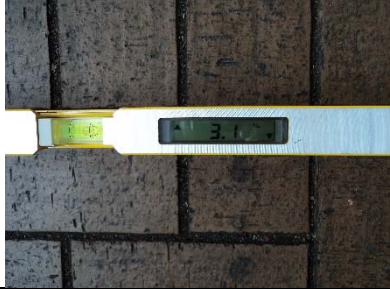
#	Location	Observed Condition	ADA Requirement
2.1.9	West lower level sidewalk (LL2) adjacent to passenger loading zone.	The cross slope of the accessible route is greater than 2%. The cross slope ranges from 2.7% up to 3.1% in this general area.	403.3 Slope. The running slope of walking surfaces shall not be steeper than 1:20. The cross slope of walking surfaces shall not be steeper than 1:48.
	<i>Photograph(s):</i>

<i>Recommended Action:</i>	No action required. The accessible route likely does not need to extend this far north of the accessible entrance. However, if the accessible

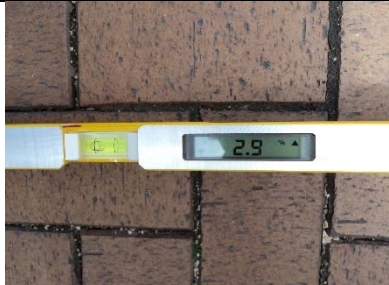
#	Location	Observed Condition	ADA Requirement
2.1.10	North upper level sidewalk (UL2) adjacent to Jackson Street Plaza.	The cross slope of the accessible route is greater than 2%. The cross slope is up to 2.9% in an isolated area.	403.3 Slope. The running slope of walking surfaces shall not be steeper than 1:20. The cross slope of walking surfaces shall not be steeper than 1:48.
	<i>Photograph(s):</i>

<i>Recommended Action:</i>	Remove and replace sections of sidewalk/pavement to reduce the cross slope to 2% maximum along the accessible route.	
	<i>Additional Comments:</i>	N/A

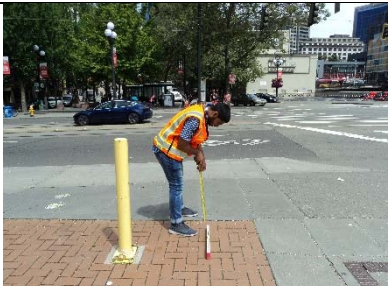
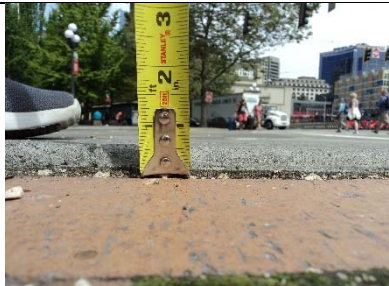
#	Location	Observed Condition	ADA Requirement
2.1.11	North upper level sidewalk (UL2) at intersection with public right-of-way (where paver units abut concrete sidewalk).	Vertical level change on accessible route is greater than ¼" vertical or ½" with a 1:2 bevel. Vertical level change is 5/8".	303.2 Vertical. Changes in level of ¼ inch (6.4 mm) high maximum shall be permitted to be vertical. 303.3 Beveled. Changes in level between ¼ inch (6.4 mm) high minimum and ½ inch (13 mm) high maximum shall be beveled with a slope not steeper than 1:2.
	<i>Photograph(s):</i>

<i>Recommended Action:</i>	Reset brick pavers so that they are flush with the concrete sidewalk.	
	<i>Additional Comments:</i>	N/A

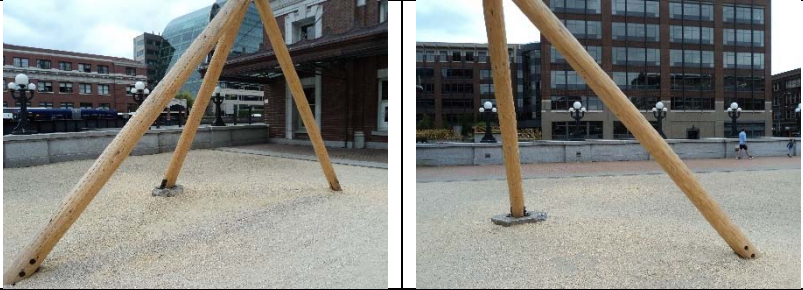
#	Location	Observed Condition	ADA Requirement
2.1.12	Sculptures installed in Jackson Street Plaza within pedestrian circulation path.	The vertical clearance is less than 80" above the ground where the sculptures rise up at angles from the base. A cane detectable barrier is not provided below.	307.2 Protrusion Limits. Objects with leading edges more than 27 inches (685 mm) and not more than 80 inches (2030 mm) above the finish floor or ground shall

<p><i>Recommended Action:</i></p>	<p>Install a low railing or other continuous cane detectable edge around the bases of the sculptures where the headroom is reduced to less than 80" above the ground.</p>	
	<p><i>Additional Comments:</i></p>	<p>While the sculptures are not installed along the accessible route, they are within the overall pedestrian circulation path, and therefore must adhere to the protruding object requirements.</p>

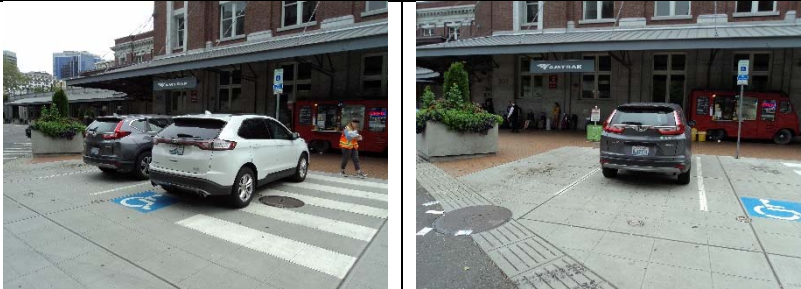
#	Location	Observed Condition	ADA Requirement
2.2.1	<p>Accessible parking space and access aisle at lower level parking area.</p>	<p>The accessible parking space provided is not on the shortest accessible route to the accessible entrance.</p>	<p>208.3.1 General. Parking spaces complying with 502 that serve a particular building or facility shall be located on the shortest <i>accessible</i> route from parking to an entrance complying with 206.4. Where parking serves more than one <i>accessible</i> entrance, parking spaces complying with 502 shall be dispersed and located on the shortest <i>accessible</i> route to the <i>accessible</i> entrances. In parking facilities that do not serve a particular building or facility, parking spaces complying with 502 shall be located on the shortest <i>accessible</i> route to an <i>accessible</i></p>

pedestrian entrance of the parking facility.
	<i>Photograph(s):</i>

<i>Recommended Action:</i>	Relocate the accessible parking space and access aisle north to the position closest to the accessible entrance. Restripe or mark the spaces as required. Verify that slopes do not exceed 2% in any direction at the relocated accessible parking space and access aisle.	
	<i>Additional Comments:</i>	N/A

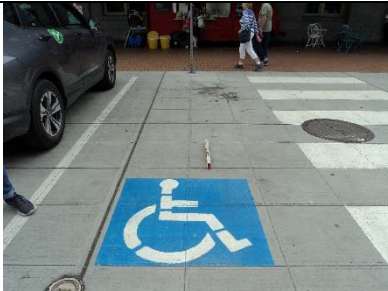
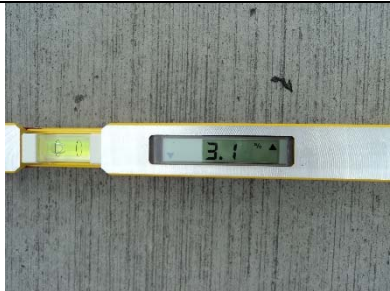
#	Location	Observed Condition	ADA Requirement
2.2.2	Accessible parking space and access aisle at lower level parking area.	The slope at the accessible parking space exceeds 2%. The slope is up to 3.1% near the center of the space.	502.4 Floor or Ground Surfaces. Parking spaces and access aisles serving them shall comply with 302. Access aisles shall be at the same level as the parking spaces they serve. Changes in level are not permitted. EXCEPTION: Slopes not steeper than 1:48 shall be permitted.
	<i>Photograph(s):</i>

<i>Recommended Action:</i>	Remove and replace sections of concrete to reduce the slope to 2% maximum within the accessible parking space.	
	<i>Additional Comments:</i>	Alternatively, if the accessible parking space is relocated as recommended in 2.2.1, no action required in this area.

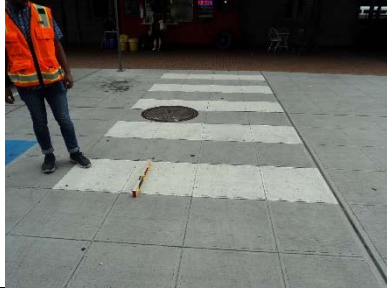
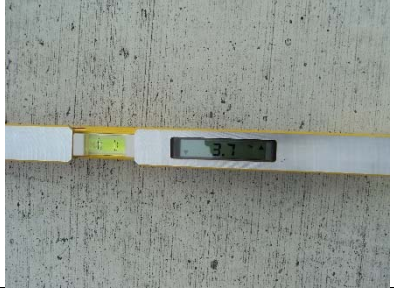
#	Location	Observed Condition	ADA Requirement
2.2.3	Accessible parking space and access aisle at lower level parking area.	The slope at the access aisle exceeds 2%. The slope is up to 3.7% at the lower portion of the access aisle.	502.4 Floor or Ground Surfaces. Parking spaces and access aisles serving them shall comply with 302. Access aisles shall be at the same level as the parking spaces they

serve. Changes in level are not permitted. EXCEPTION: Slopes not steeper than 1:48 shall be permitted.
	Photograph(s):

Recommended Action:	Remove and replace sections of concrete to reduce the slope to 2% maximum within the access aisle.	
	Additional Comments:	Alternatively, if the accessible parking space is relocated as recommended in 2.2.1, no action required in this area.

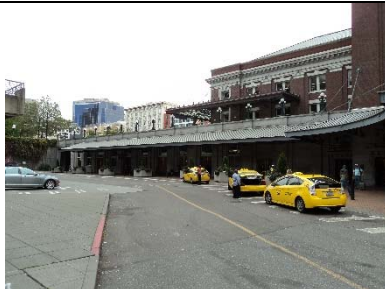
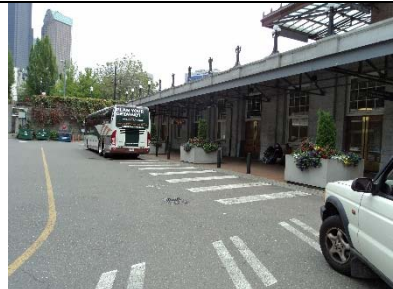
#	Location	Observed Condition	ADA Requirement
2.3.1	Lower level passenger loading zone area.	An accessible portion of the loading zone was unable to be identified. <i>Note: Three sections of the overall passenger loading zone, those closest to the accessible entrance, were observed.</i>	209.2.1 Passenger Loading Zones. Passenger loading zones, except those required to comply with 209.2.2 and 209.2.3, shall provide at least one passenger loading zone complying with 503 in every continuous 100 linear feet (30 m) of loading zone space, or fraction thereof. PROWAG R211.4 Accessible Parking Space and Passenger Loading Zone Signs. Accessible parking spaces and accessible passenger loading zones shall be identified by signs displaying the International Symbol of Accessibility complying with R411. At accessible parallel parking spaces and accessible passenger loading zones, the signs shall be located at the head or foot of the parking space or passenger loading zone.

<i>Recommended Action:</i>	Refer to the observations identified in this section to determine the appropriate location for an accessible loading zone, based on proximity to the accessible entrance and remediations necessary in efforts to achieve an accessible loading zone.	
	<i>Additional Comments:</i>	While the 2010 ADA Standards do not require that the accessible passenger loading zone to be identified, the Public Rights-of-Way Accessibility Guidelines recommend signage including the International Symbol of Accessibility (refer to R211.4 above for additional information).

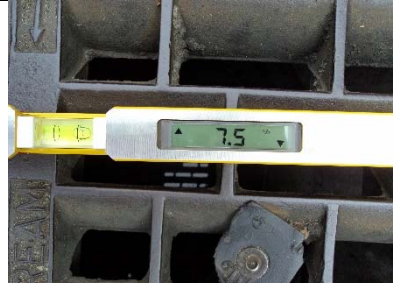
#	Location	Observed Condition	ADA Requirement
	Lower level passenger loading zone area (first area from the south approach from King Street, PLZ1).	The slope at the access aisle exceeds 2%. The slope is up to 7.5% at or near the drainage inlet.	503.4 Floor and Ground Surfaces. Vehicle pull-up spaces and access aisles serving them shall comply with 302. Access aisles shall be at the same level as the vehicle pull-up space they serve. Changes in level are not permitted. EXCEPTION: Slopes not steeper than 1:48 shall be permitted.
2.3.2	<i>Photograph(s):</i>

<i>Recommended Action:</i>	Remove and replace sections of asphalt to reduce the slope to 2% maximum within the access aisle. Adjust the drainage inlet as necessary.	
	<i>Additional Comments:</i>	Alternatively, locate the accessible passenger loading zone at one of the other available areas.

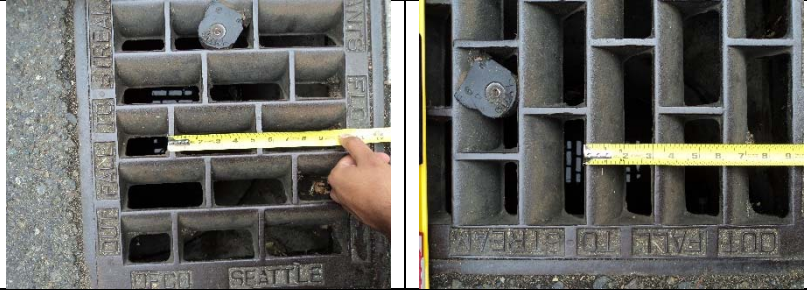
#	Location	Observed Condition	ADA Requirement
2.3.3	Lower level passenger loading zone area (first area from the south approach from King Street, PLZ1).	The drainage inlet openings within the access aisle are greater than ½". The openings are 5" wide and 3" deep.	503.4 Floor and Ground Surfaces. Vehicle pull-up spaces and access aisles serving them shall comply with 302. Access aisles shall be at the same level as

Recommended Action:	Remove and replace the drainage inlet grate with one that has openings no larger than 1/2".	
	Additional Comments:	Alternatively, locate the accessible passenger loading zone at one of the other available areas.

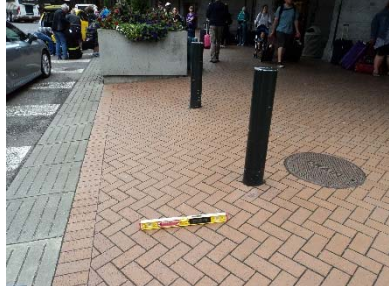
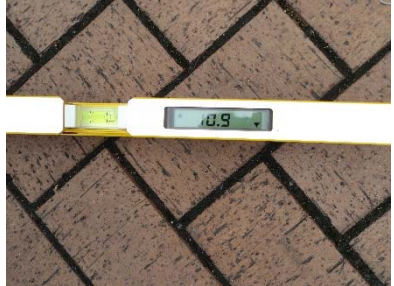
#	Location	Observed Condition	ADA Requirement
2.3.4	Lower level passenger loading zone area (first area from the south approach from King Street, PLZ1).	The access aisle does not adjoin an accessible route. The running slope of the route exceeds 5% (or 8.3% for a ramp) at up to 10.9%	503.3 Access Aisle. Passenger loading zones shall provide access aisles complying with 503 adjacent to the vehicle pull-up space. Access aisles shall adjoin an accessible route and shall not overlap the vehicular way.
	Photograph(s):

Recommended Action:	Remove and replace sections of sidewalk/pavement to reduce the slope to 5% maximum or provide a compliant curb ramp.	
	Additional Comments:	Alternatively, locate the accessible passenger loading zone at one of the other available areas.

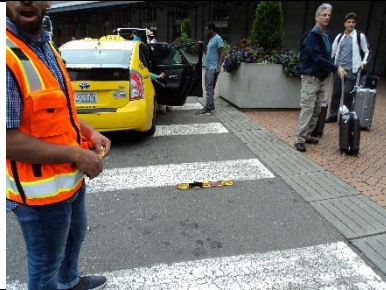
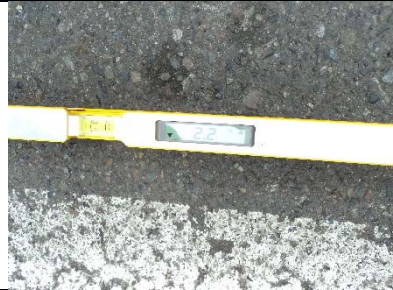
#	Location	Observed Condition	ADA Requirement
2.3.5	Lower level passenger loading zone area (second area from the south approach from King Street, PLZ2).	The slope at the access aisle exceeds 2%. The slope is up to 2.2% near the center of the aisle. <i>Note: this may be considered within a reasonable construction tolerance for existing conditions.</i>	503.4 Floor and Ground Surfaces. Vehicle pull-up spaces and access aisles serving them shall comply with 302. Access aisles shall be at the same level as the vehicle pull-up space they serve. Changes in level are not permitted.

Recommended Action:	Remove and replace sections of asphalt to reduce the slope to 2% maximum within the access aisle.	
	Additional Comments:	Alternatively, locate the accessible passenger loading zone at one of the other available areas.

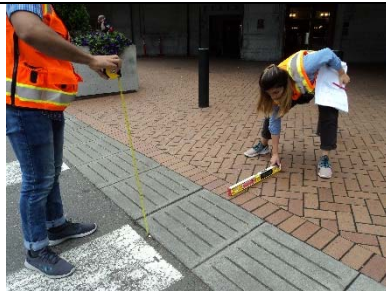
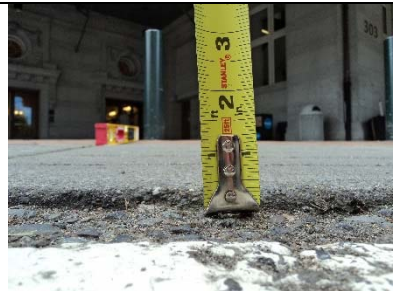
#	Location	Observed Condition	ADA Requirement
2.3.6	Lower level passenger loading zone area (second area from the south approach from King Street, PLZ2).	The access aisle does not adjoin an accessible route. The vertical level change between the access aisle and the concrete is greater than ¼” at 3/8”. <i>Note: this may be considered within a reasonable construction tolerance for existing conditions.</i>	503.3 Access Aisle. Passenger loading zones shall provide access aisles complying with 503 adjacent to the vehicle pull-up space. Access aisles shall adjoin an accessible route and shall not overlap the vehicular way.
	Photograph(s):

Recommended Action:	Apply asphalt or pavement to match elevation between the two surfaces.	
	Additional Comments:	Alternatively, locate the accessible passenger loading zone at one of the other available areas.

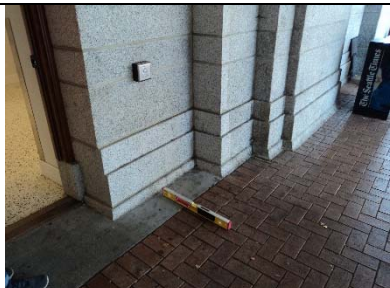
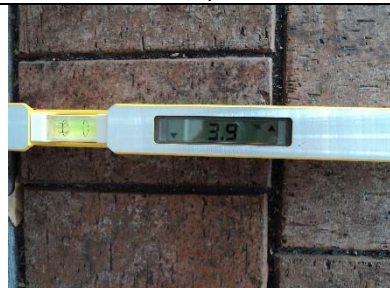
#	Location	Observed Condition	ADA Requirement
2.4.1	Lower level accessible entrance (identified by International Symbol of Accessibility).	The slope at the clear floor/ground space for access to the automatic door pushbutton exceeds 2%. The slope is up to 3.9% directly below the pushbutton.	305.2 Floor or Ground Surfaces. Floor or ground surfaces of a clear floor or ground space shall comply with 302. Changes in level are not permitted. EXCEPTION: Slopes not steeper than 1:48 shall be permitted.
	<i>Photograph(s):</i>

<i>Recommended Action:</i>	Remove and replace sections of pavement to reduce the slope to 2% maximum within the required clear floor/ground space.	
	<i>Additional Comments:</i>	Alternatively, relocate the pushbutton to a location where the slope of the sidewalk is no more than 2% but within close proximity of the door it serves.

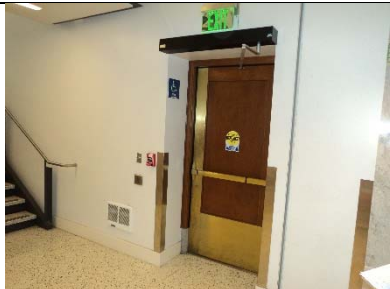
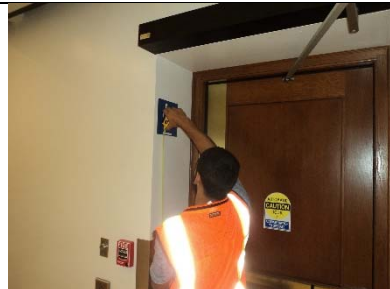
#	Location	Observed Condition	ADA Requirement
2.4.2	Lower level accessible entrance (identified by International Symbol of Accessibility).	The tactile characters on the exit sign are higher than 60" to the baseline of the highest character. The baseline of the highest character 73" above the floor.	703.4.1 Height Above Finish Floor or Ground. Tactile characters on signs shall be located 48 inches (1220 mm) minimum above the finish floor or ground surface, measured from the baseline of the lowest tactile character and 60 inches (1525 mm) maximum above the finish floor or ground surface, measured from the baseline of the highest tactile character.
	<i>Photograph(s):</i>

<i>Recommended Action:</i>	Relocate the tactile sign at the egress door to the required location.	
<i>Additional Comments:</i>	Refer to 2010 ADA Standards 703.4.2 for additional locational requirements for the signage.

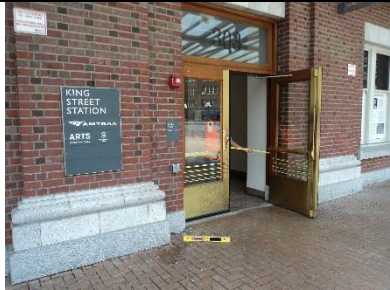
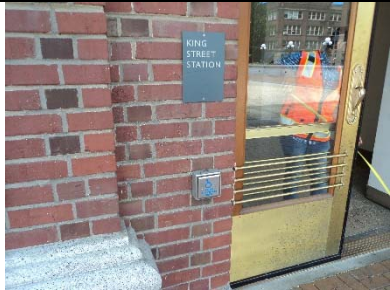
#	Location	Observed Condition	ADA Requirement
2.4.3	Upper level accessible entrance.	The International Symbol of Accessibility is not provided at the entrance door.	216.6 Entrances. Where not all entrances comply with 404, entrances complying with 404 shall be identified by the International Symbol of Accessibility complying with 703.7.2.1. Directional signs complying with 703.5 that indicate the location of the nearest entrance complying with 404 shall be provided at entrances that do not comply with 404.
	<i>Photograph(s):</i>

<i>Recommended Action:</i>	Provide the International Symbol of Accessibility at the intended accessible entrance.	
	<i>Additional Comments:</i>	While the pushbutton at the door does include the ISA, it is not believed that this alone satisfies the signage requirement.

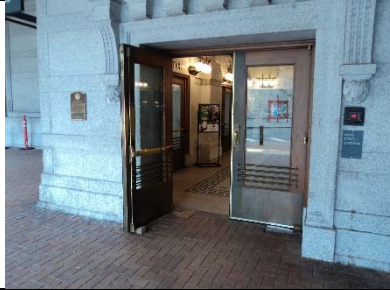
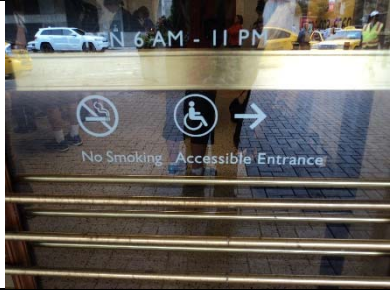
#	Location	Observed Condition	ADA Requirement
2.4.4	Exterior entrances (all).	Directional signage is not provided, clearly provided, or provided with the correct orientation or information at all entrances required.	216.6 Entrances. Where not all entrances comply with 404, entrances complying with 404 shall be identified by the International Symbol of Accessibility complying with 703.7.2.1. Directional signs complying with 703.5 that indicate the location of the nearest entrance complying with 404 shall be provided at entrances that do not comply with 404.
	<i>Photograph(s):</i>

<i>Recommended Action:</i>	Provide compliant directional signage indicating the location of the nearest accessible entrance at each exterior public entry door applicable. Verify that the direction indicated points to the intended accessible entrance. Per the WAC, the ISA must be white on a blue background.

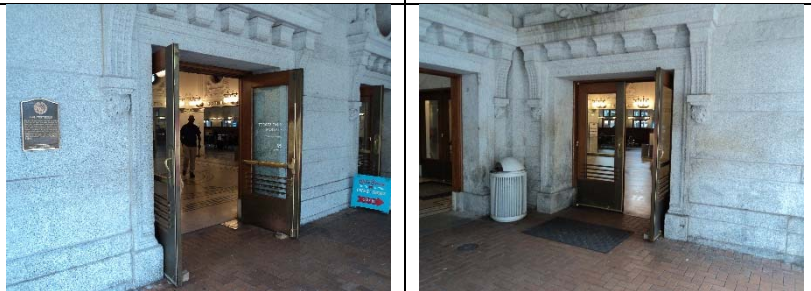
#	Location	Observed Condition	ADA Requirement
2.4.5	Exterior entrances (all).	Accessible room identification signage is not provided, provided at the correct location, or includes the required information at all exterior doors identifying permanent rooms and spaces.	216.2 Designations. Interior and exterior signs identifying permanent rooms and spaces shall comply with 703.1, 703.2, and 703.5. Where pictograms are provided as designations of permanent interior rooms and spaces, the pictograms shall comply with 703.6 and shall have text descriptors complying with 703.2 and 703.5.
	<i>Photograph(s):</i>

<i>Recommended Action:</i>	No action required. Accessible room or space identification signage is not typically required to be installed at the exterior of a building.	
	<i>Additional Comments:</i>	It was observed that there is some signage provided at the exterior of the building that includes raised tactile features and Braille, though not clearly required.

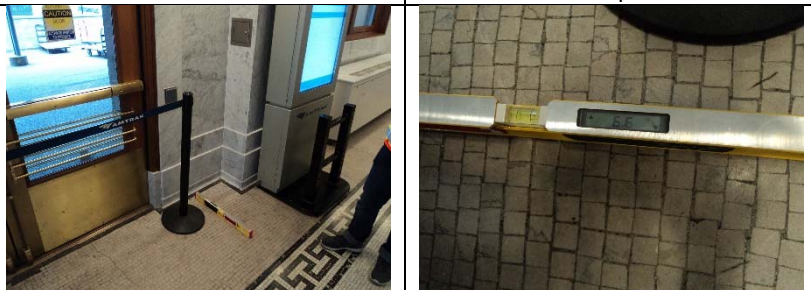
#	Location	Observed Condition	ADA Requirement
2.4.6	Passenger lobby automatic door (at Gate 8)	The slope at the clear floor/ground space for access to the automatic door pushbutton exceeds 2%. The slope is up to 6.6% directly below the pushbutton.	305.2 Floor or Ground Surfaces. Floor or ground surfaces of a clear floor or ground space shall comply with 302. Changes in level are not permitted. EXCEPTION: Slopes not steeper than 1:48 shall be permitted.
	<i>Photograph(s):</i>

<i>Recommended Action:</i>	Remove and replace sections of flooring to reduce the slope to 2% maximum within the required clear floor/ground space.

<i>Additional Comments:</i>	<p>Alternatively, relocate the pushbutton to a location where the slope of the floor is no more than 2% but within close proximity of the door it serves.</p> <p><i>Note: It was observed that passengers are typically sent out the exterior door at Gate 4 for access to all trains; staff props the door open to allow for adequate passenger access.</i></p>
--	-----------------------------	--
