Seattle Department of Transportation

The Americans with Disabilities Act (ADA) Transition Plan for the Seattle Public Right-of-Way

Appendix 5.6a: 2019 King Street Station ADA Assessment Report

2019 King Street Station ADA Assessment Report

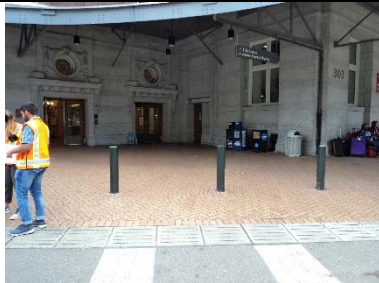
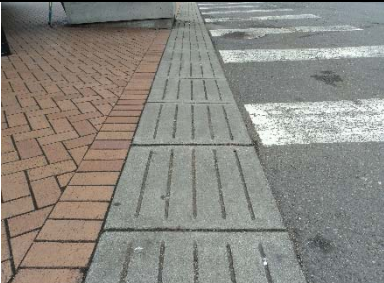
#	Location	Observed Condition	ADA Requirement
	<p>Lower level passenger loading zone area.</p>	<p>A detectable warning surface is not provided where the street and the sidewalk are flush.</p>	<p>PROWAG R208.1 Where Required. Detectable warning surfaces complying with R305 shall be provided at the following locations on pedestrian access routes and at transit stops:</p> <ol style="list-style-type: none"> 1. Curb ramps and blended transitions at pedestrian street crossings;
<p>2.3.8</p>	<p><i>Photograph(s):</i></p>

<p><i>Additional Comments:</i></p>	<p>The existing pavement is textured and contrasts the adjacent brick pavers, which may be detectable for people with vision impairments.</p>

<p><i>Recommended Action:</i></p>	<p>No action required. The 2010 ADA Standards do not require detectable warning surfaces in this scenario. The Public Right-of-Way Accessibility Guidelines call for detectable warning at curb ramps or blended transitions at street crossings. It is recommended to have a tactile or discernable edge to separate the sidewalk from the loading zone, similar to what is currently in place.</p>

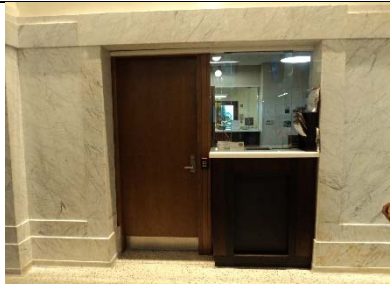
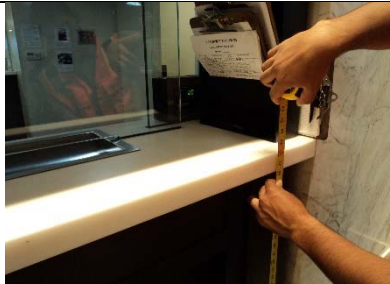
#	Location	Observed Condition	ADA Requirement
3.3.2	Main passenger ticketing sales counter.	The alternate service/sales/support counter to the left of the main sales counters is not accessible or does not have a lower, accessible portion. The counter is 48" high.	904.4.1 Parallel Approach. A portion of the counter surface that is 36 inches (915 mm) long minimum and 36 inches (915 mm) high maximum above the finish floor shall be provided. A clear floor or ground space complying with 305 shall be positioned for a parallel approach adjacent to the 36 inch (915 mm) minimum length of counter.
	<i>Photograph(s):</i>

<i>Recommended Action:</i>	No action required. The sales and services provided are managed by Amtrak, and it their responsibility to ensure that each type of service offered is accessible to their customers.
	<i>Additional Comments:</i>	In the future, if SDOT or the City of Seattle assumes operation of these sales counters and facilities, it will need to be determined what services are provided. If different services are provided or available at each sales counter, they will need to include an accessible portion.

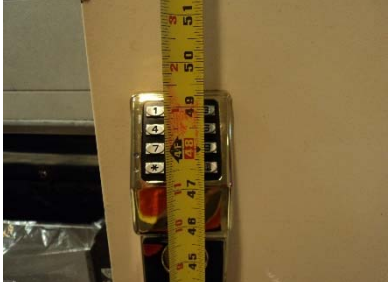
#	Location	Observed Condition	ADA Requirement
<p>3.4.1</p>	<p>Lobby family toilet room door.</p>	<p>The keypad, required for access into the toilet room, is mounted higher than 48” above the floor. The centerline of the highest operable button is at 49”.</p>	<p>308.2.1 Unobstructed. Where a forward reach is unobstructed, the high forward reach shall be 48 inches (1220 mm) maximum and the low forward reach shall be 15 inches (380 mm) minimum above the finish floor or ground.</p>
	<p><i>Photograph(s):</i></p>

<p><i>Recommended Action:</i></p>	<p>Relocate or lower the keypad so that all operable parts are at or below 48” above the floor.</p>

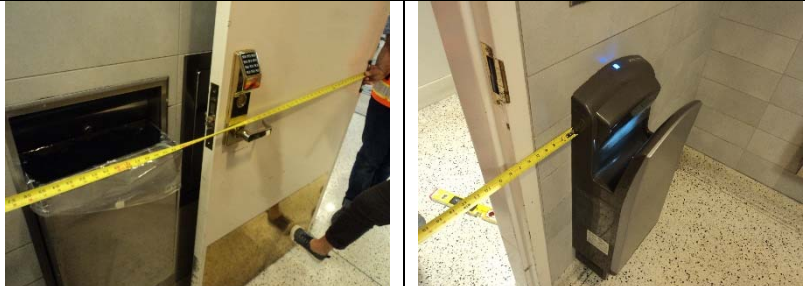
#	Location	Observed Condition	ADA Requirement
3.4.3	Lobby family toilet room door.	The required door maneuvering clearance on the pull side of the door is not provided due to the location of toilet room accessories. The pull side clearance is less than 24" on the latch side for a latch-side approach at 7" to the hand dryer.	404.2.4 Maneuvering Clearances. Minimum maneuvering clearances at doors and gates shall comply with 404.2.4. Maneuvering clearances shall extend the full width of the doorway and the required latch side or hinge side clearance.
	<i>Photograph(s):</i>

<i>Recommended Action:</i>	Relocate the hand dryer to provide a minimum of 24" clearance adjacent to the latch for a latch-side approach on the pull side of the door. It is noted that the hand dryer extends more than 8" into the required clearance.
	<i>Additional Comments:</i>	A forward approach to the door on the pull side is not available, as the clear depth between the door opening and the lavatory is 58".

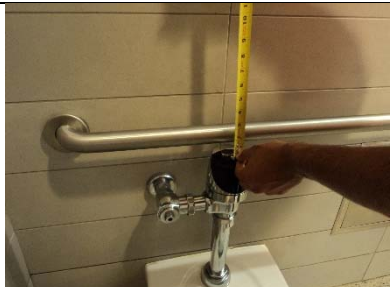
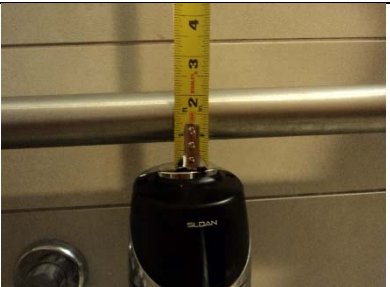
#	Location	Observed Condition	ADA Requirement
3.4.5	Lobby family toilet room grab bars.	The clearance below the water closet rear grab bars is less than 1-1/2" at 3/4".	609.3 Spacing. The space between the wall and the grab bar shall be 1½ inches (38 mm). The space between the grab bar and projecting objects below and at the ends shall be 1½ inches (38 mm) minimum. The space between the grab bar and projecting objects above shall be 12 inches (305 mm) minimum.
	<i>Photograph(s):</i>

<i>Recommended Action:</i>	Provide at least 1-1/2" clearance below the grab bars.
	<i>Additional Comments:</i>	Ensure that, if the grab bars are raised in order to provide the required clearance, the top gripping surface of the grab bars is located between 33" and 36" above the floor.

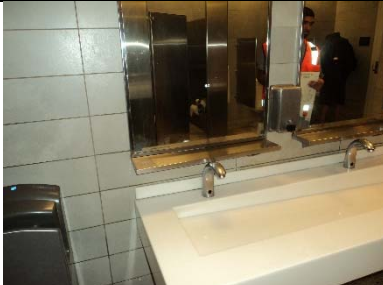
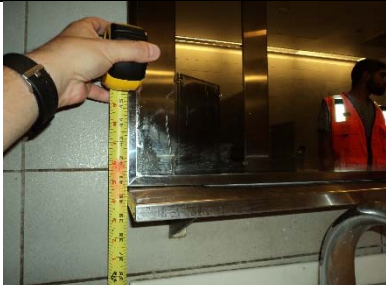
#	Location	Observed Condition	ADA Requirement
3.4.8	Lobby men's toilet room lavatory.	The mirror above the lavatory is mounted higher than 40" above the floor at 41-1/4".	603.3 Mirrors. Mirrors located above lavatories or countertops shall be installed with the bottom edge of the reflecting surface 40 inches (1015 mm) maximum above the finish floor or ground. Mirrors not located above lavatories or countertops shall be installed with the bottom edge of the reflecting surface 35 inches (890 mm) maximum above the finish floor or ground.
	<i>Photograph(s):</i>

<i>Recommended Action:</i>	Relocate the mirror for at least one section of the lavatory so that the bottom of the reflective surface is mounted no higher than 40" above the floor.	
	<i>Additional Comments:</i>	N/A

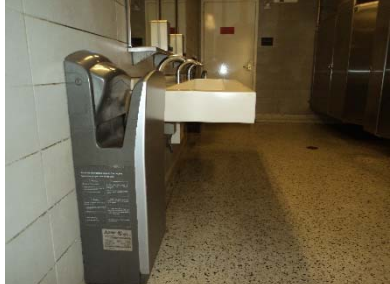
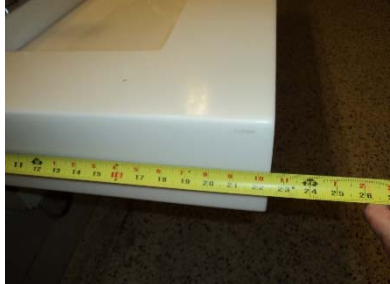
#	Location	Observed Condition	ADA Requirement
3.4.10	Lobby women's toilet room lavatory.	The lavatory countertop protrudes more than 4" into the pedestrian circulation path where the lower edge is greater than 27" above the floor. The lower edge of the countertop is at 27-1/2" above the floor, and the counter projects 22-1/2" from the wall.	307.2 Protrusion Limits. Objects with leading edges more than 27 inches (685 mm) and not more than 80 inches (2030 mm) above the finish floor or ground shall protrude 4 inches (100 mm) maximum horizontally into the circulation path. 307.4 Vertical Clearance. Vertical clearance shall be 80 inches (2030 mm) high minimum. Guardrails or other barriers shall be provided where the vertical clearance is less than 80 inches (2030 mm) high. The leading edge of such guardrail or barrier shall be located 27 inches (685 mm) maximum above the finish floor or ground.

<i>Recommended Action:</i>	Install an apron below the lavatory or cane detectable shields or barriers at the end of the lavatory.
	<i>Additional Comments:</i>	N/A
